# Manhole Inspection Summary

Manhole # S71G\_\_019MH

Insp Date: **5/21/08 7:17 AM**

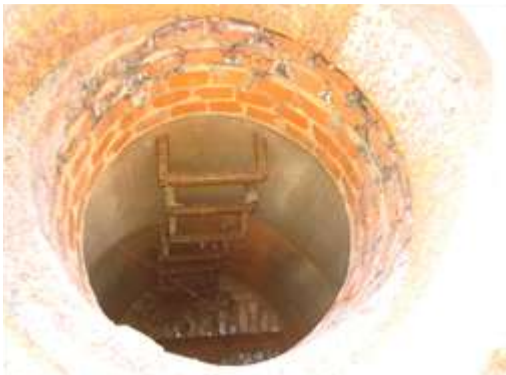
Defect 1

**Frame** Offset: **4** (in.) Condition: ☒ Sound ☐ Cracked ☐ Leaks

frame leaks

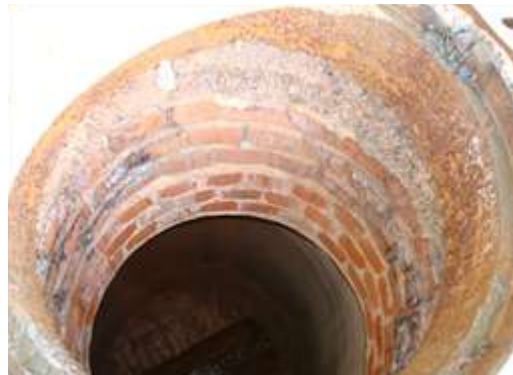
Defect 2

Infiltration: ☐ None ☒ **Joint** ☐ Cracks ☐ Mortar ☐ Roots ☐ Wall

Infiltration: ☐ None ☐ Joint ☐ Cracks ☐ Mortar ☐ Roots ☒ **Wall**

infiltration

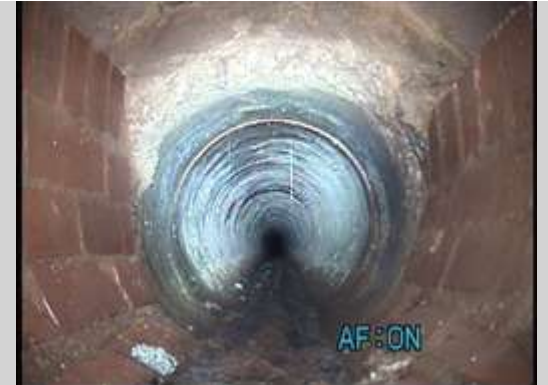
12 O'Clock Outflow

15 in. Circular Gravity Sewer  
Pipe Out @ 12 O'Clock

Pipe Height: **15.6** (in.) Rod and Bar (Angled)  
Pipe Material: **PVC** ☐ Pipe Lined  
Invert Depth: **11.90** (ft.) Flow Characteristics: **Fast**  
Deposits: ☒ None ☐ Mud ☐ Sludge ☐ Debris ☐ Grease  
Silt Depth: (in.) Deposits Extent:  
Infiltration: **None** Pipe Seal Cond: **Sound**

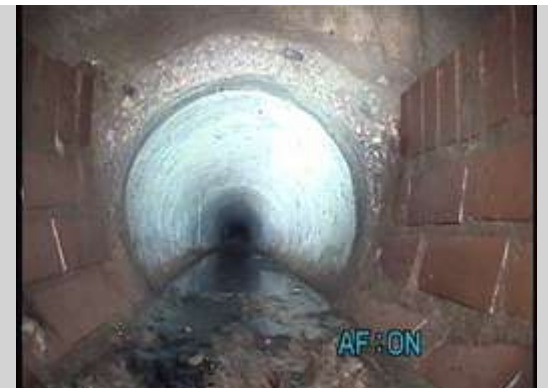
6 O'Clock Inflow

15 in. Circular Gravity Sewer  
Pipe In @ 6 O'Clock

Pipe Height: **15.6** (in.) Rod and Bar (Angled)  
Pipe Material: **PVC** ☐ Pipe Lined  
Invert Depth: **11.80** (ft.) Flow Characteristics: **Fast**  
Deposits: ☒ None ☐ Mud ☐ Sludge ☐ Debris ☐ Grease  
Silt Depth: (in.) Deposits Extent:  
Infiltration: **None** Pipe Seal Cond: **Sound**
